STATE OF CALIFORNIA
CALIFORNIA NATURAL RESOURCES AGENCY
DEPARTMENT OF WATER RESOURCES
DIVISION OF SAFETY OF DAMS

INSPECTION OF DAM AND RESERVOIR IN CERTIFIED STATUS

Name of Dam Murphys Wastewater Dam No. 2024 County Calaveras
 Type of Dam Earth Type of Spillway Drop Inlet/Culvert/Open Channel
 Water is 5 feet below spillway crest and 9 feet below dam crest.

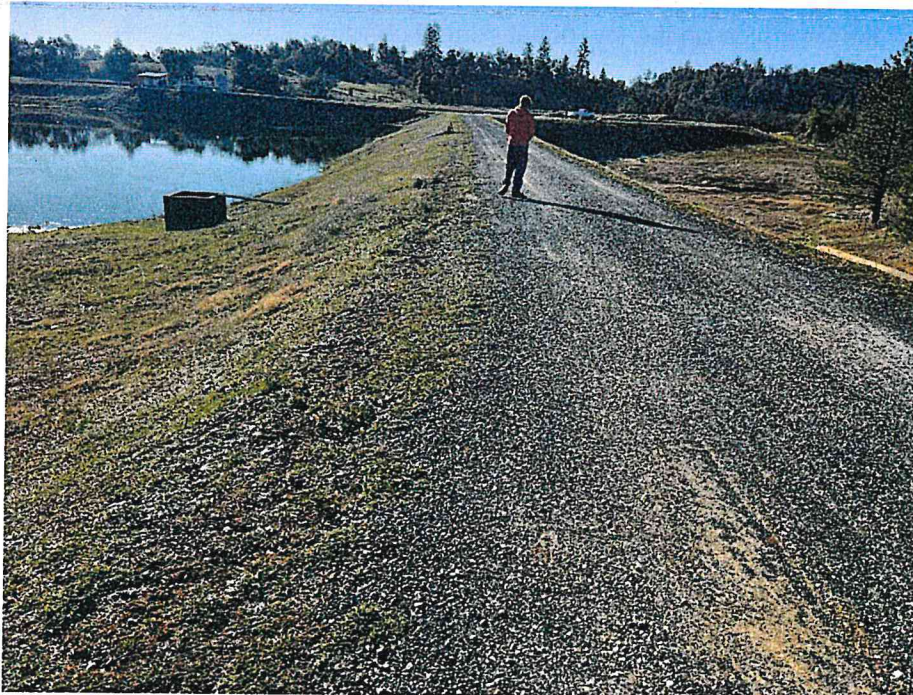
1. Upstream face of west dike with good vegetation control.

1. Continue with annual vegetation and rodent control efforts.
2. Repair the vent-pipe on the low outlet control controls.

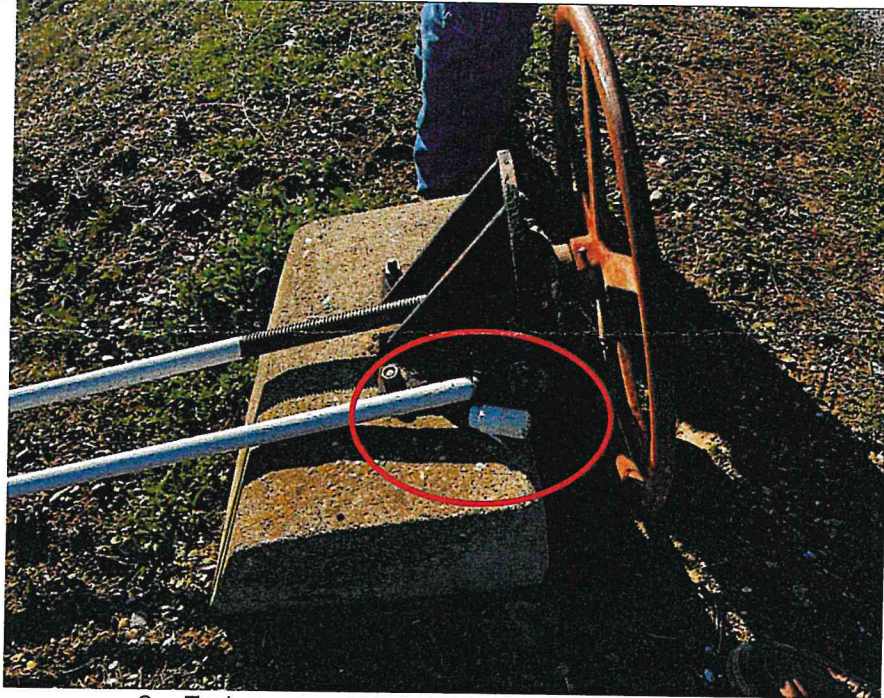
<u>Outlet</u>	The low-level outlet is located at the West Dike and controlled by an upstream slide gate. The controller, on the crest, for the upstream slide gate appeared well maintained; however, the end plug of the outlet vent pipe had fallen out. We requested the vent pipe be repaired. There is no downstream control on the outlet pipe. The controls of the gate were cycled during the 07/22/2020 inspection and they operated satisfactorily. We notified the owner that the outlet needs to be fully cycled annually per the requirements specified in the CA Water Code. All low-level outlet controls need to be cycled in our presence during the next scheduled inspection.

2. End cap repair required at outlet vent pipe.

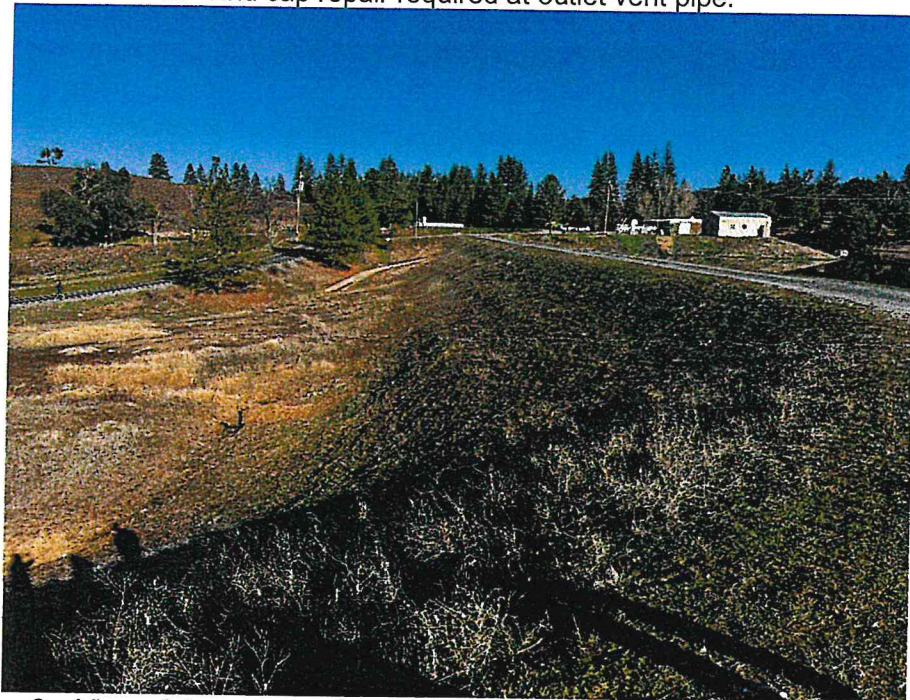
As requested during the previous inspection, the large rodent holes on the downstream face of the dam have been backfilled and compacted with fill material.

3. View of downstream face of the West Dike from left abutment.

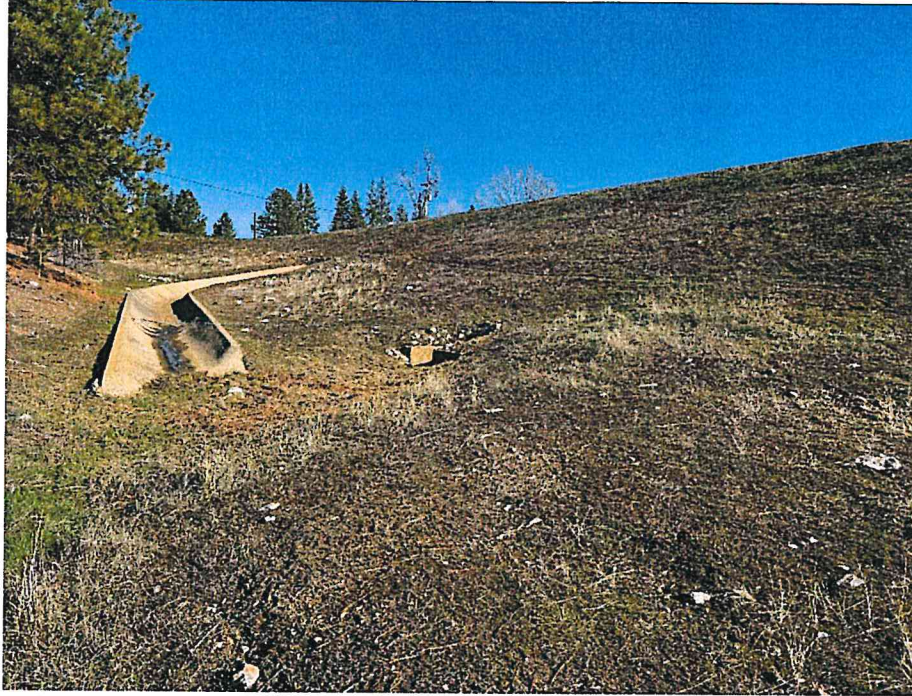
4. Concrete lined spillway channel observed looking upstream

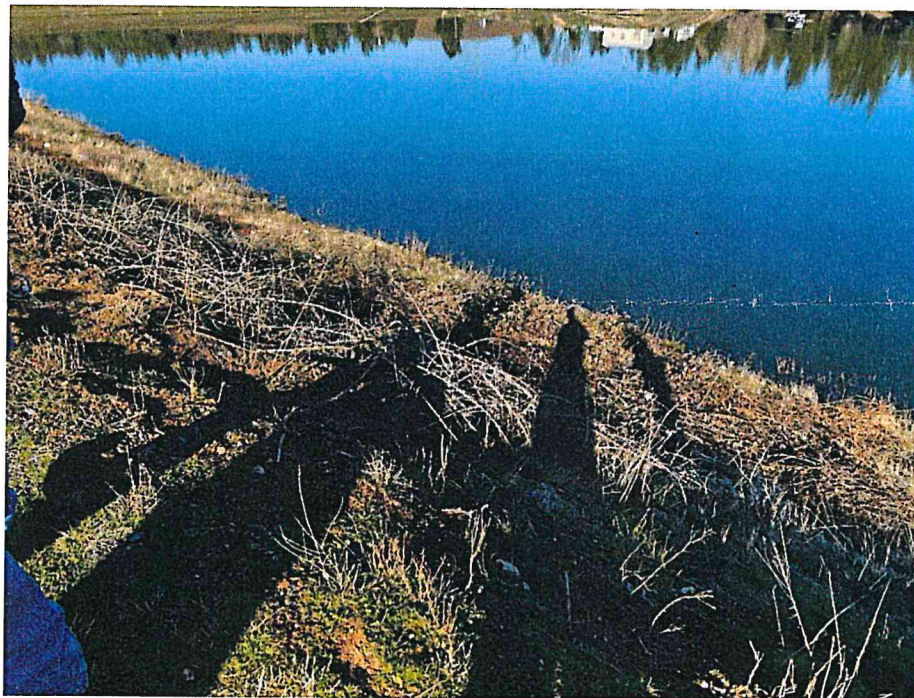
5. Continued vegetation control of berry vine brush required on the upstream face of East Dike.

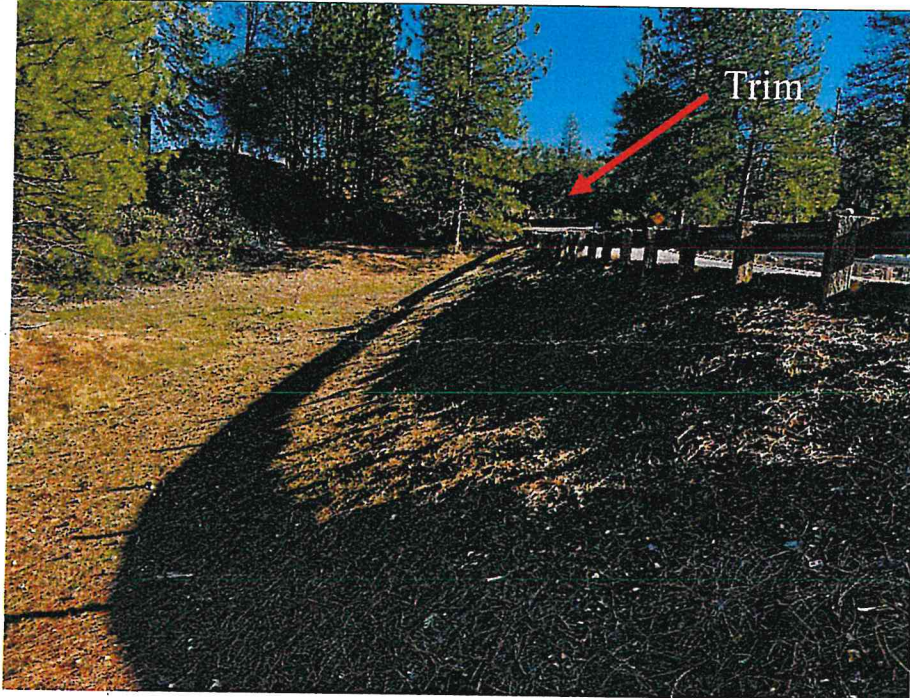
6. Main Dam downstream face observed from left side. Trimming of marked low hanging branches required.

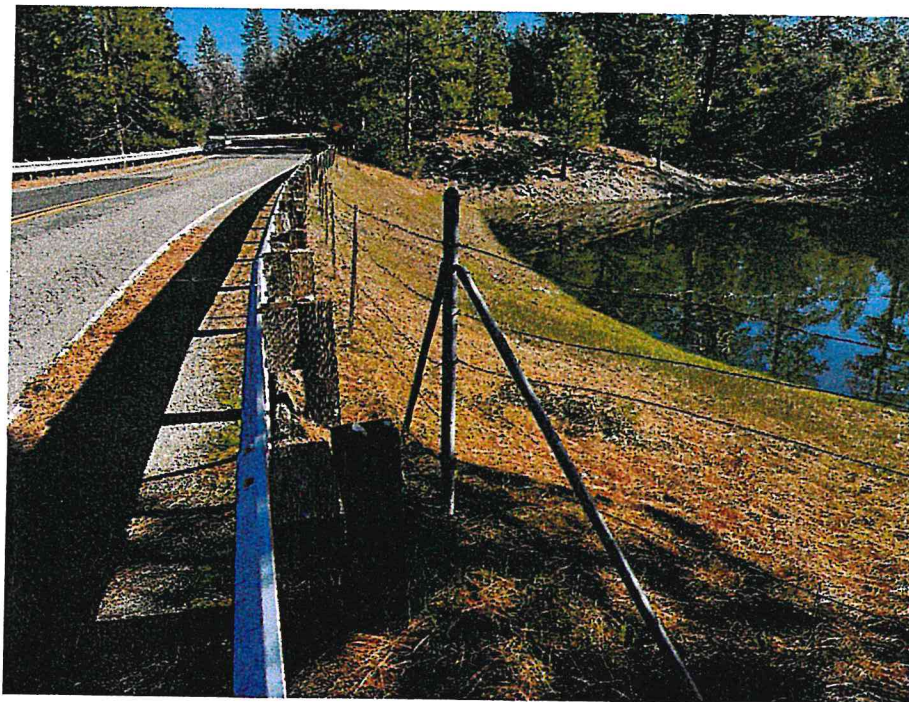
7. Main Dam upstream face observed from left side.

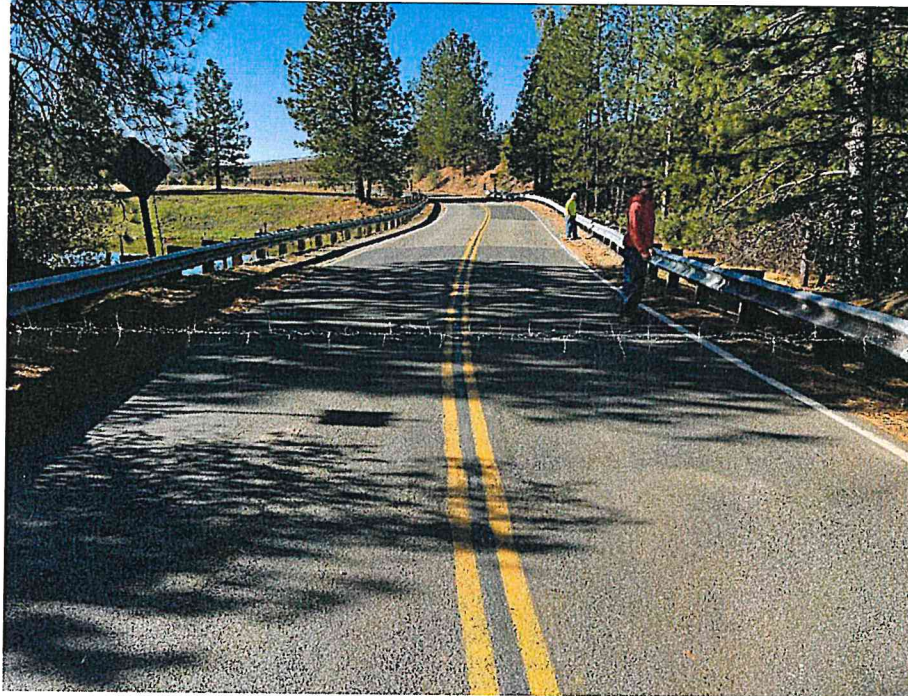
8. Main Dam crest observed from right side.
